New Hampshire Volunteer Lake Assessment Program

2003 Biennial Report for Warren Lake Alstead

NHDES
Water Division
Watershed Management Bureau
29 Hazen Drive
Concord, NH 03301

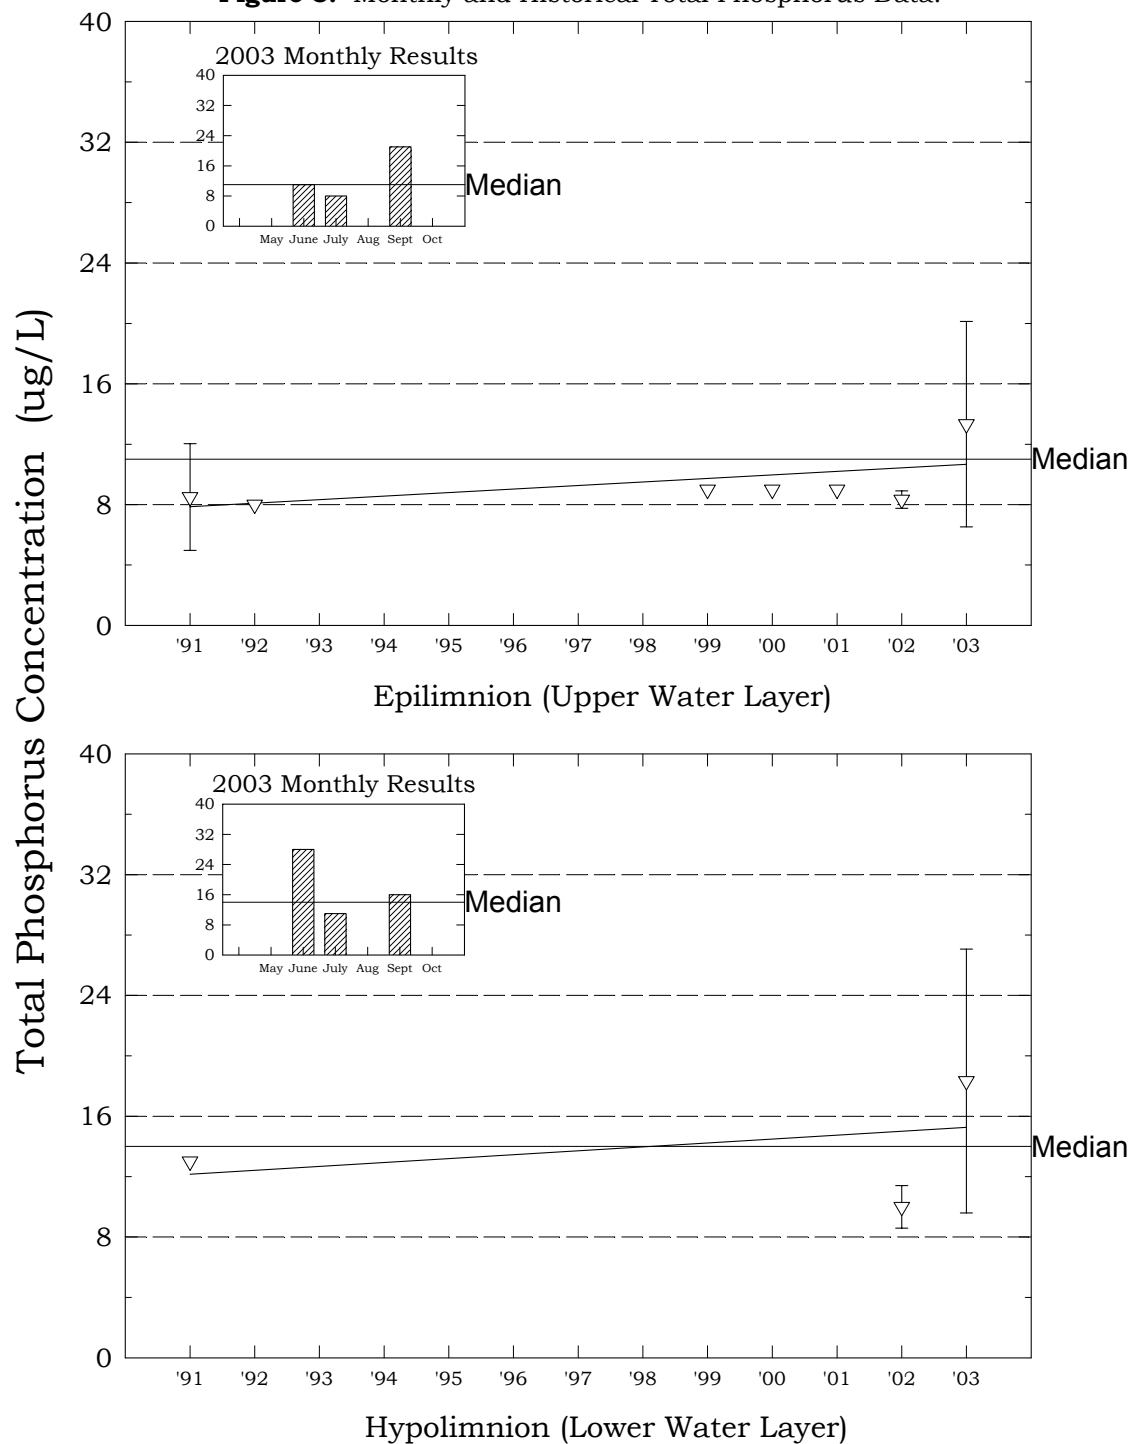
Figure 3. Monthly and Historical Total Phosphorus Data.

- **Figure 3 and Table 8:** The graphs in Figure 3 (Appendix A) show the amounts of phosphorus in the epilimnion (the upper layer) and the hypolimnion (the lower layer); the inset graphs show current year data. Table 8 (Appendix B) lists the annual maximum, minimum, and median concentration for each deep spot layer and each tributary since the lake has joined the program.

The current year data for the epilimnion (the top inset graph) show that the phosphorus concentration **decreased** from June to July, and then **increased** from July to September. The phosphorus concentration in June was **approximately equal to** the state median, in July was **less than** the state median, and in September was **greater than** the state median.

The historical data show that the 2003 mean epilimnetic phosphorus concentration is **greater than** the state median.

The current year data for the hypolimnion (the bottom inset graph) show that the phosphorus concentration **decreased** from June to July, and then **increased** from July to September. The phosphorus concentration in June, and September was **greater than** the state median, but in July it was **less than** the state median.

The historical data show that the 2003 mean hypolimnetic phosphorus concentration is **greater than** the state median.

Overall, visual inspection of the historical data trend line for the epilimnion show **a relatively stable** phosphorus trend, which means that the concentration has **remained approximately the same** in the epilimnion since monitoring began.

Overall, visual inspection of the historical data trend line for the hypolimnion shows **an increasing** phosphorus trend, which means that the concentration has **worsened** in the hypolimnion since monitoring began. If the monitoring group continues to collect three samples per summer, we will be better able to discuss this trend.

One of the most important approaches to reducing phosphorus loading to a waterbody is to continually educate watershed residents about its sources and how excessive amounts can adversely impact the ecology and value of lakes and ponds. Phosphorus sources within a lake or pond's watershed typically include septic systems, animal waste, lawn fertilizer, road and construction erosion, and natural wetlands.
